DEPARTMENT OF TRANSPORTATION**DIVISION OF ENGINEERING SERVICES**

Quality Assurance and Source Inspection

Contract #: 04-0120F4Cty: SF/ALA Rte: 80 PM: 13.2/13.9File #: 1.28**WELDING INSPECTION REPORT****Resident Engineer:** Pursell, Gary**Address:** 333 Burma Road**City:** Oakland, CA 94607**Report No:** WIR-000365**Date Inspected:** 17-Aug-2007**Project Name:** SAS Superstructure**OSM Arrival Time:** 700**Prime Contractor:** American Bridge/Fluor Enterprises, a JV**OSM Departure Time:** 1500**Contractor:** American Bridge/Fluor Enterprises, a JV**Location:** Benicia, CA**CWI Name:** Michael Johnson**CWI Present:** Yes No**Inspected CWI report:** Yes No N/A**Rod Oven in Use:** Yes No N/A**Electrode to specification:** Yes No N/A**Weld Procedures Followed:** Yes No N/A**Qualified Welders:** Yes No N/A**Verified Joint Fit-up:** Yes No N/A**Approved Drawings:** Yes No N/A**Approved WPS:** Yes No N/A**Delayed / Cancelled:** Yes No N/A**Bridge No:** 34-0006**Component:** Procedure Qualification Record (PQR) Test**Summary of Items Observed:**

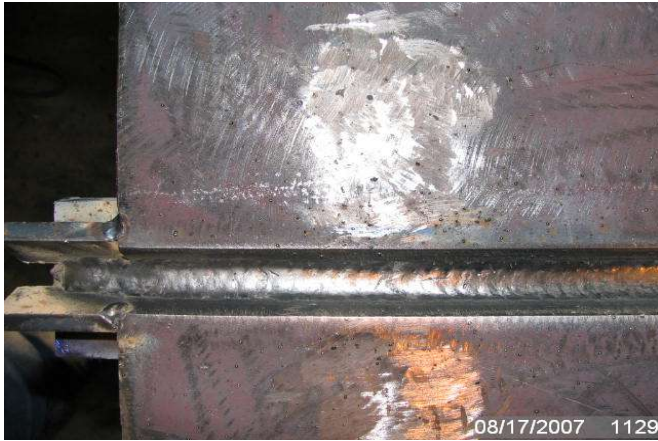
The QA Inspector informed the QC Inspector that he observed possible piping porosity scattered throughout the root pass of the above mentioned PQR test plate. The QC Inspector informed the QA Inspector that this was considered surface chicken scratch and will be easily removed by grinding. The QA Inspector observed the root pass was ground and observed the ground surface with the aid of a bright white light and magnification and detected what appeared to be very small (nearly un-measurable) round indications scattered occasionally throughout the root weld pass. The QA Inspector informed the QC Inspector and ABF Representatives Mr. Tommy Gibson of the above mentioned discrepancy. See attached photo for additional information.
